CATEGORY I DAM INSPECTION (BIENNIAL)
NELSON HILL SUBDIVISION LAKE DAM
for the
NELSON HILL HOMEOWNERS' ASSOCIATION
Hahira, Lowndes County, GA

TPE Project No. NEL 001

March 27, 2026

DAM INSPECTION REPORT (*Biennial P.E. Inspection*)

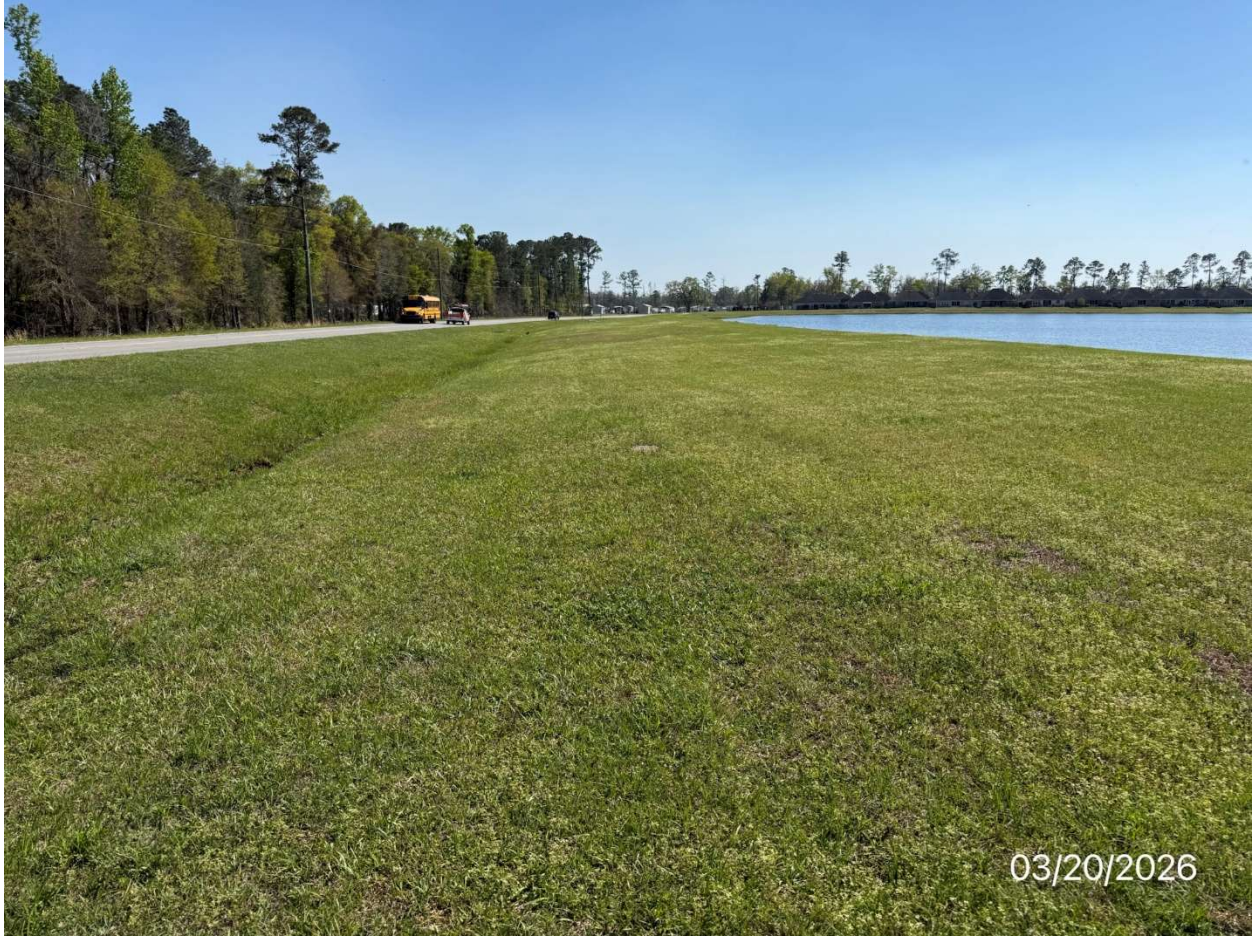
Picture #1 – Typical crest and backslope

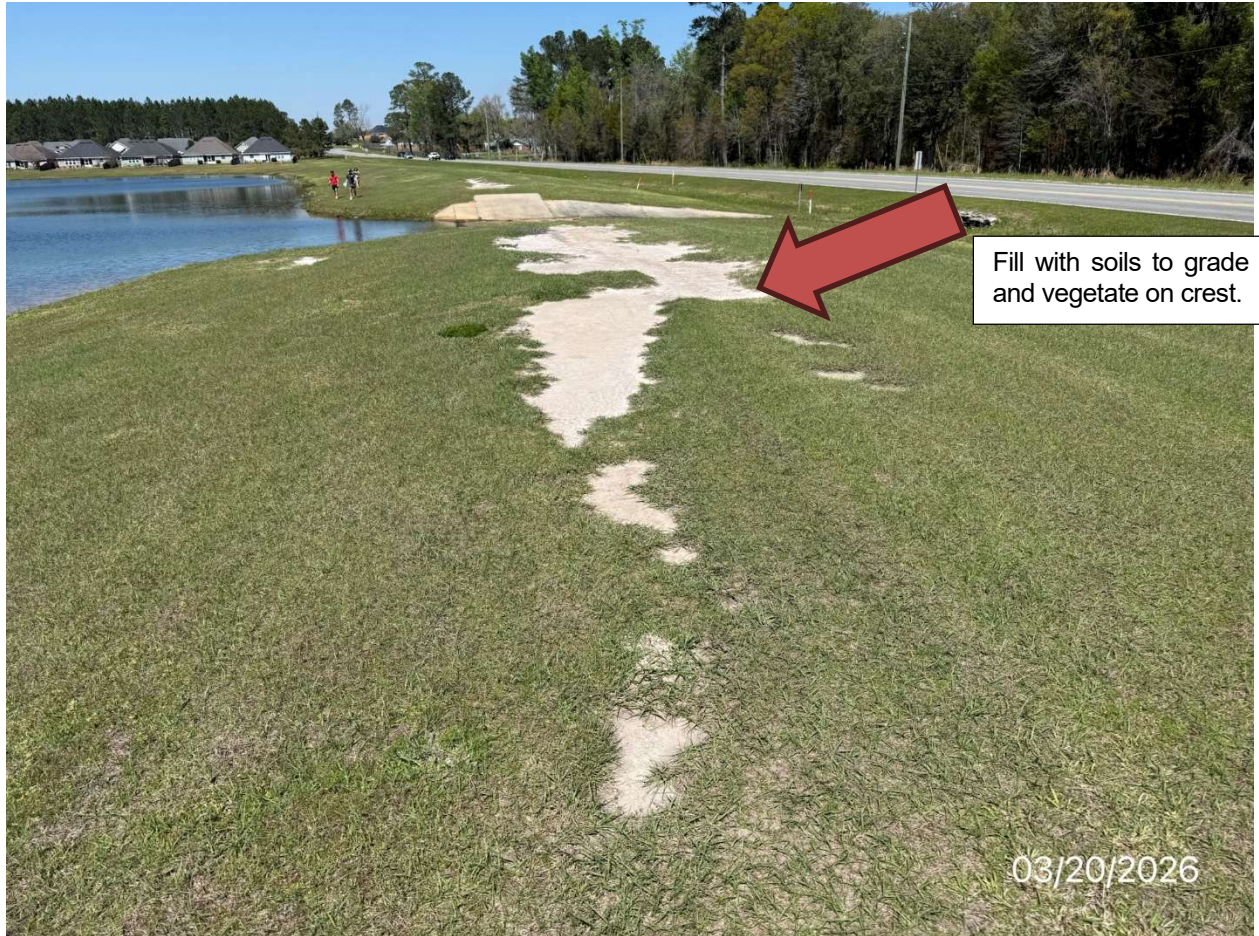
Picture #2 - Crest Condition south of the concrete spillway. Add soil and grass (\pm 80' x 15')

1. How would you describe the vegetation on the crest? (Check all that apply)
Recently Mowed X Overgrown _____ Good Cover _____ Sparse _____
Other/Corrective Action (describe): Bare spots and minor erosion in isolated locations need fill and re-vegetation. See pictures #2 and #3.

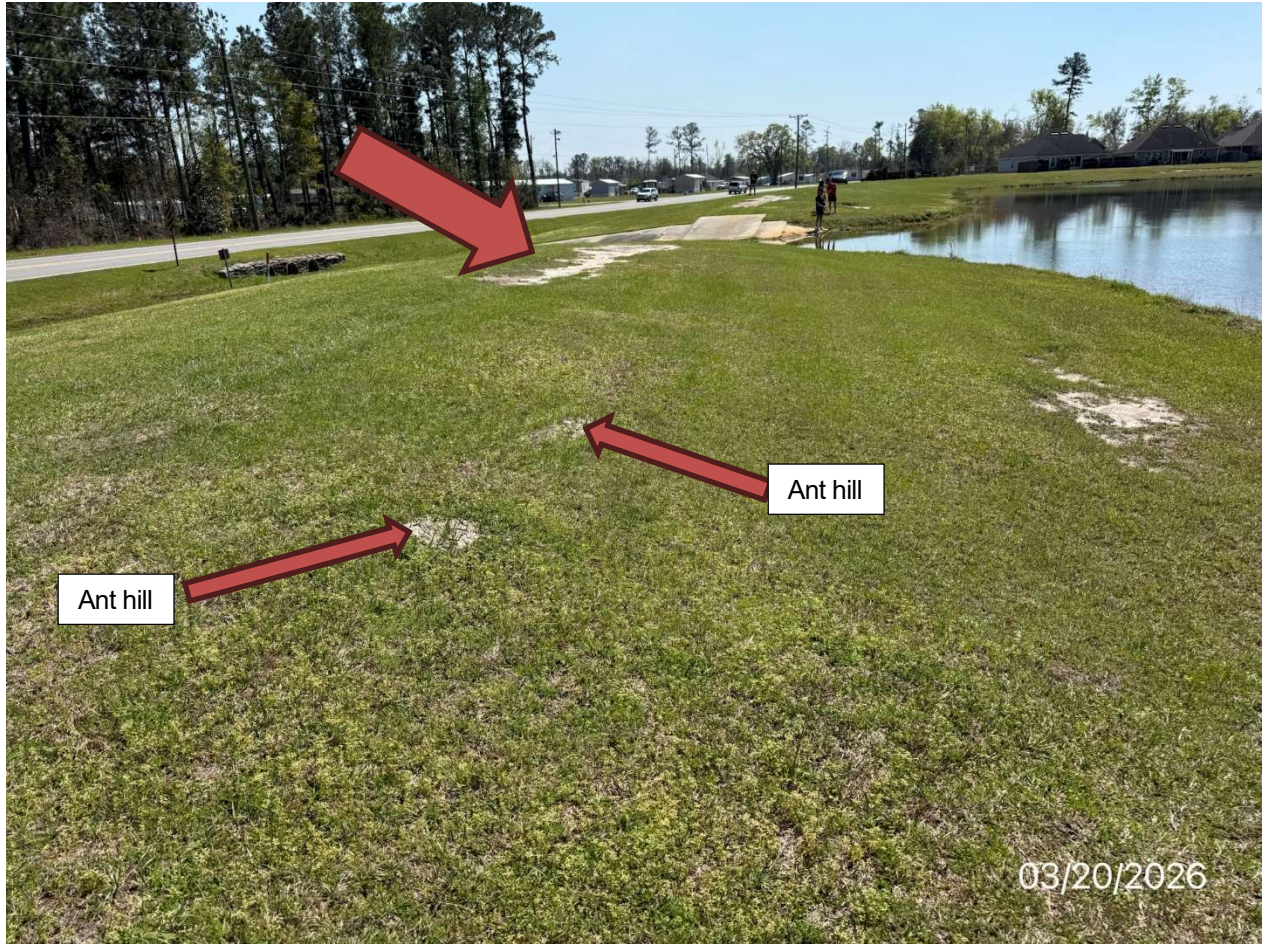
Picture #3 - Crest Condition north of the concrete spillway. Add soil and grass ($\pm 40' \times 10'$)
Multiple ant hills need to be removed over length of dam.

4. Are there any depressions, ruts or holes on the crest? Yes X No _____
If yes, describe (size, location, etc.)/Corrective Action: Multiple ant hills exist on the crest that must be eliminated.

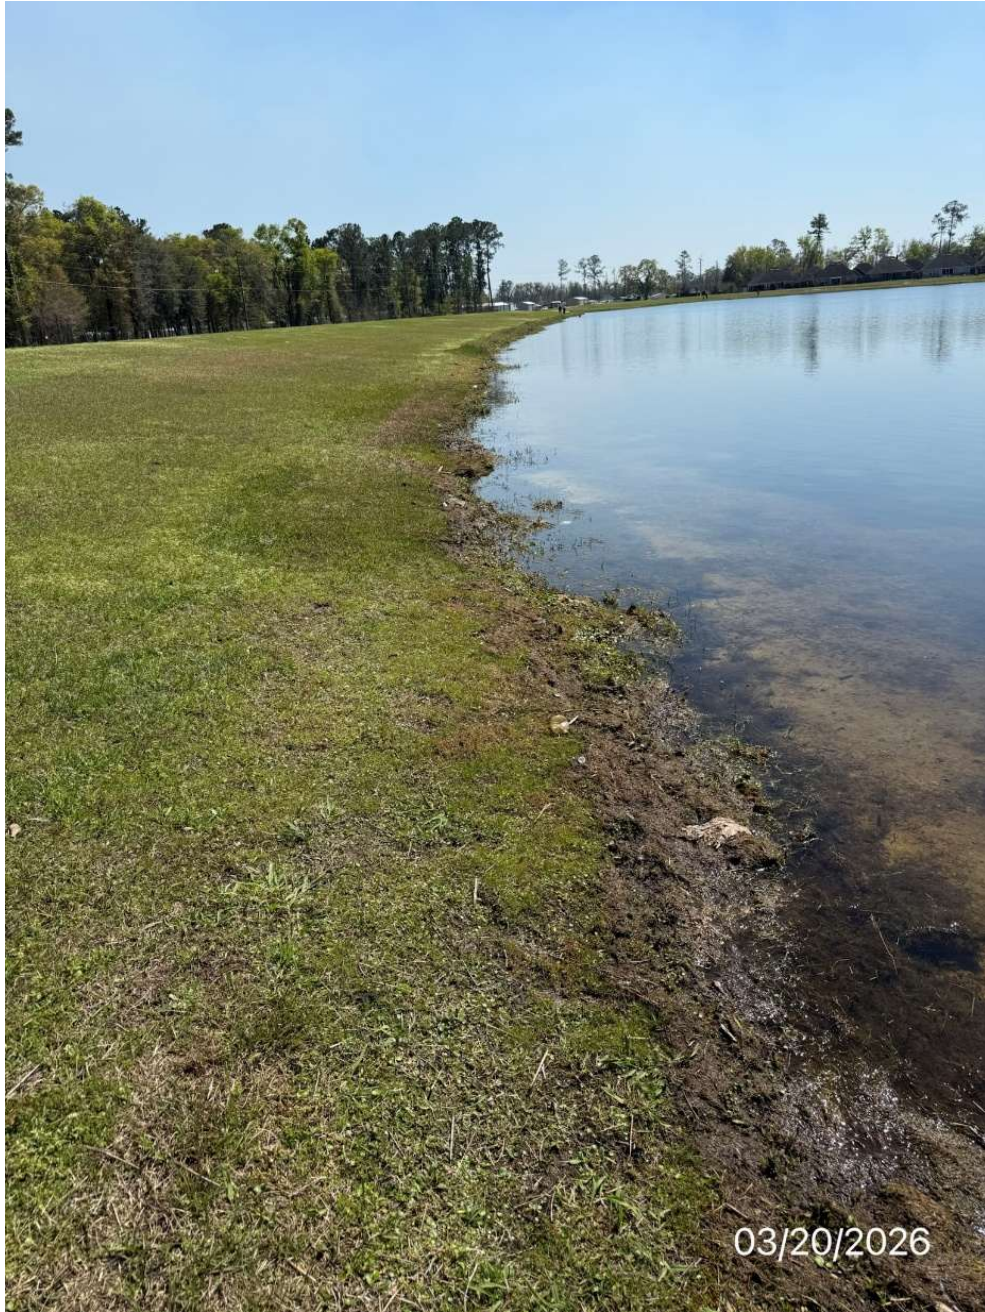
Picture #4 - Typical upstream slope condition.

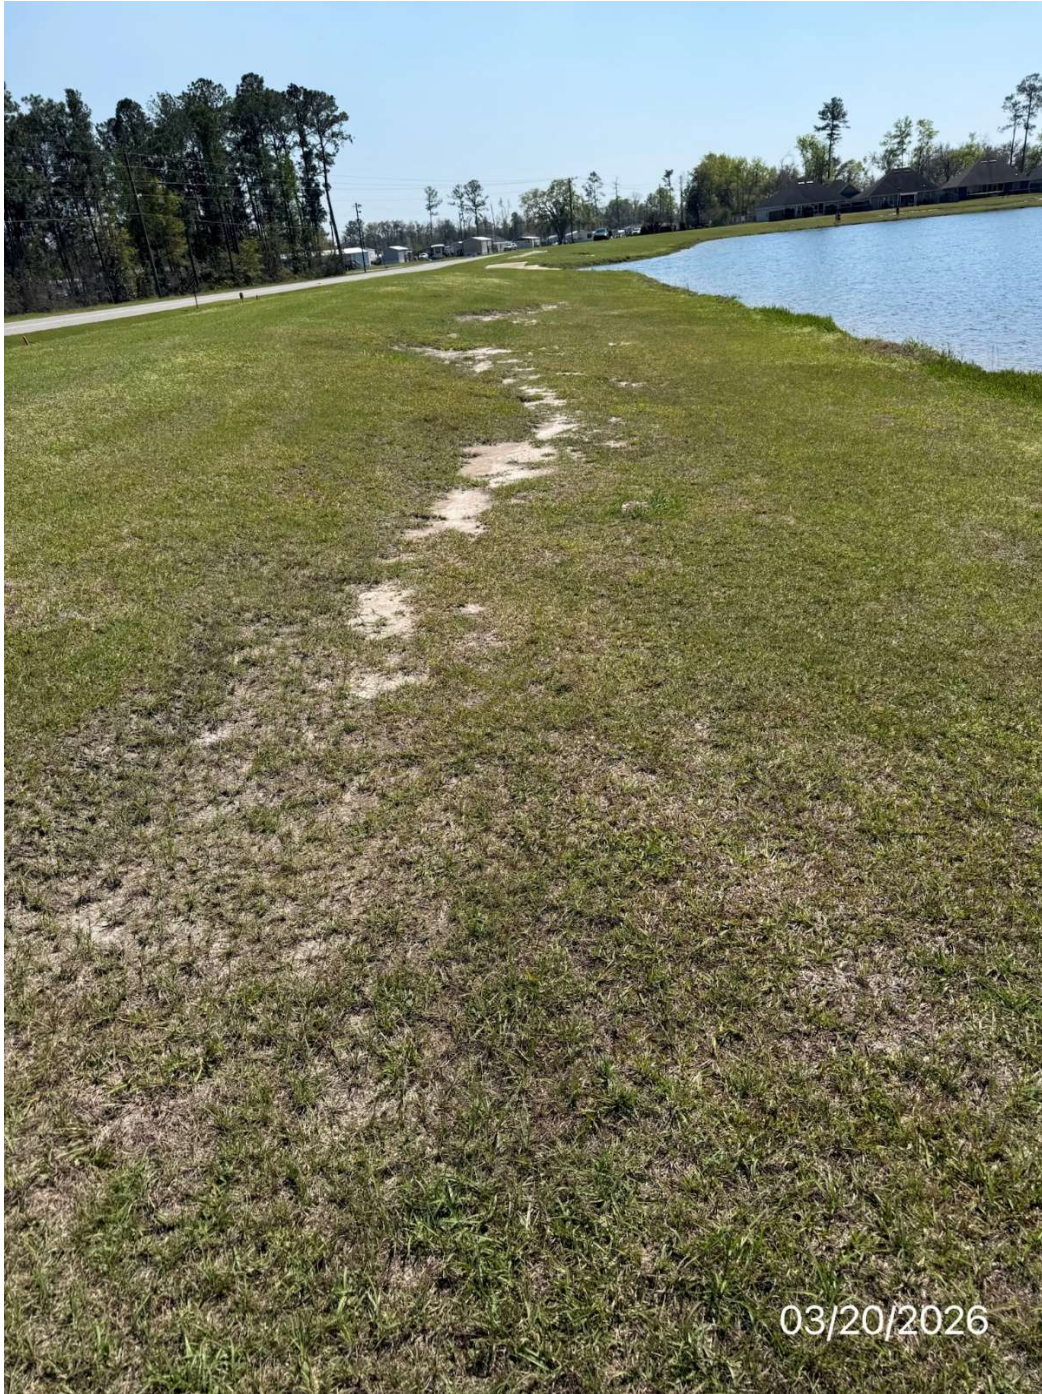
Picture #5 - Upstream slope located north of the principal spillway. Add soil to replace eroded bare spots and grass (+120 x 15' area)

5. Are there any eroded areas on the slope (such as wave erosion along the shoreline)? Yes X No _____
If yes, describe (size of area, location, severity, etc.)/Corrective Action: _____
Bare spot and minor erosion in isolated locations need fill and re-vegetation. See pictures #2, 5, 6, & 7.

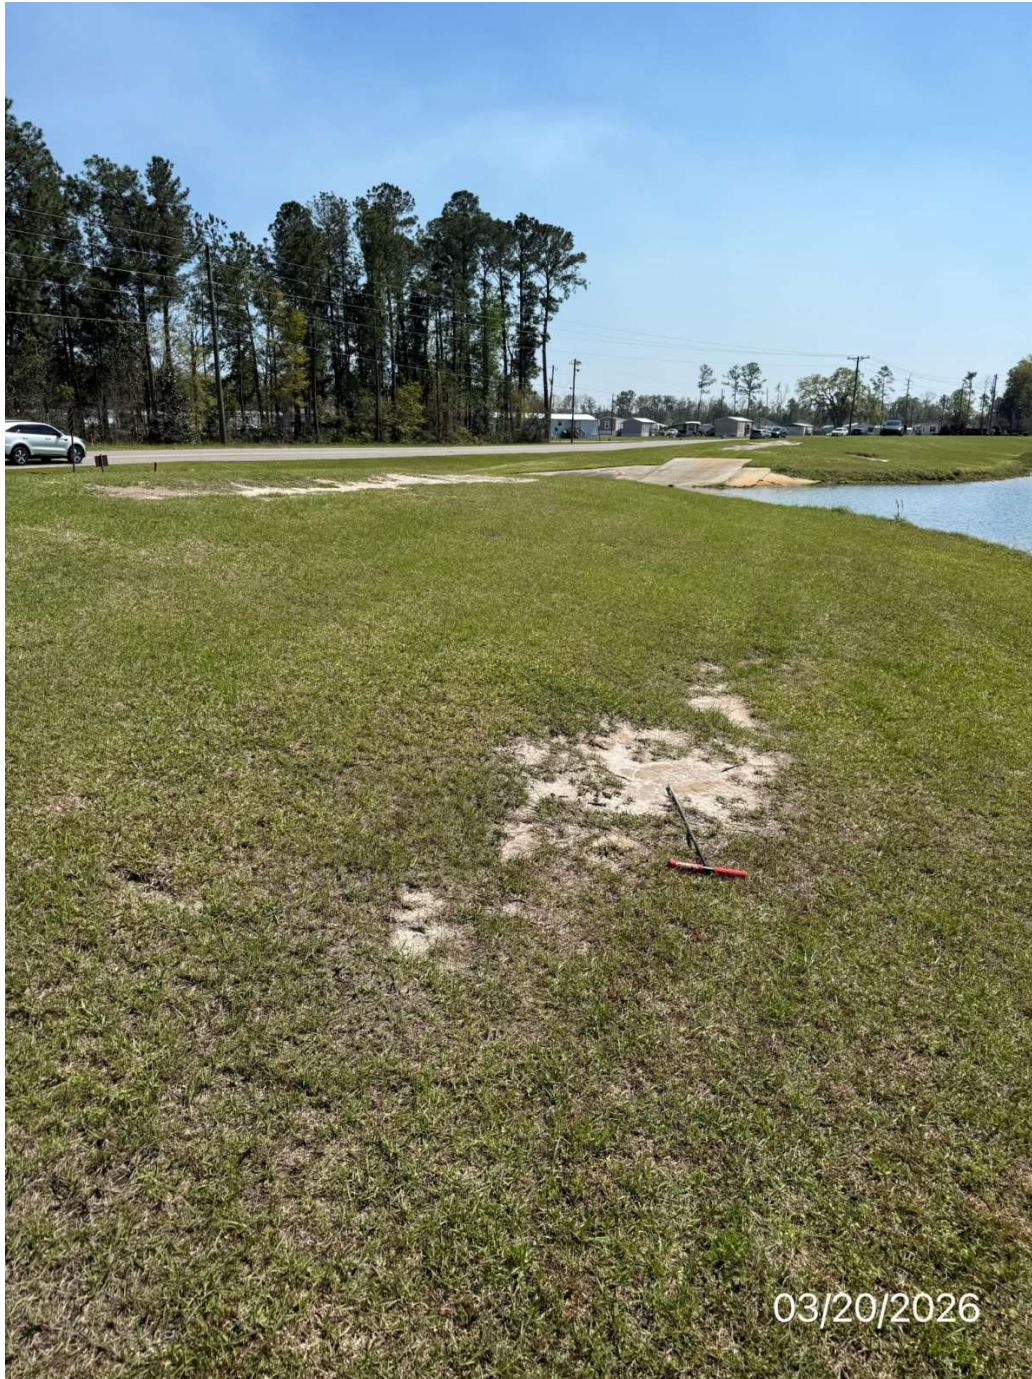
Picture #6 - Upstream slope located north of the principal spillway. Add soil to replace eroded bare spots and grass. ($\pm 20 \times 6'$ area)

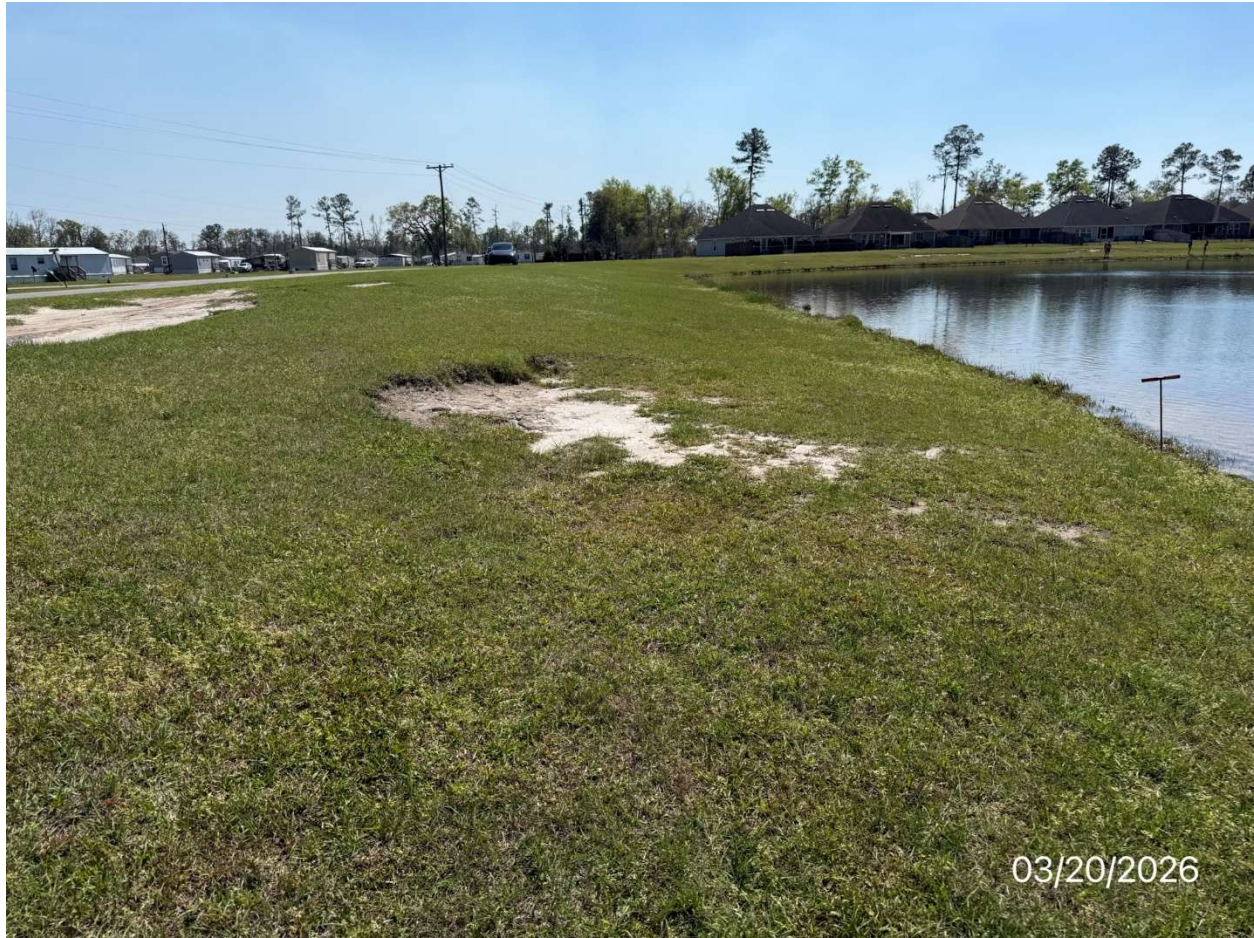
Picture #7 - Upstream slope located south of the principal spillway. Add soil to replace eroded bare spots and grass. ($\pm 20 \times 15'$ area, about 10" to 12" required)

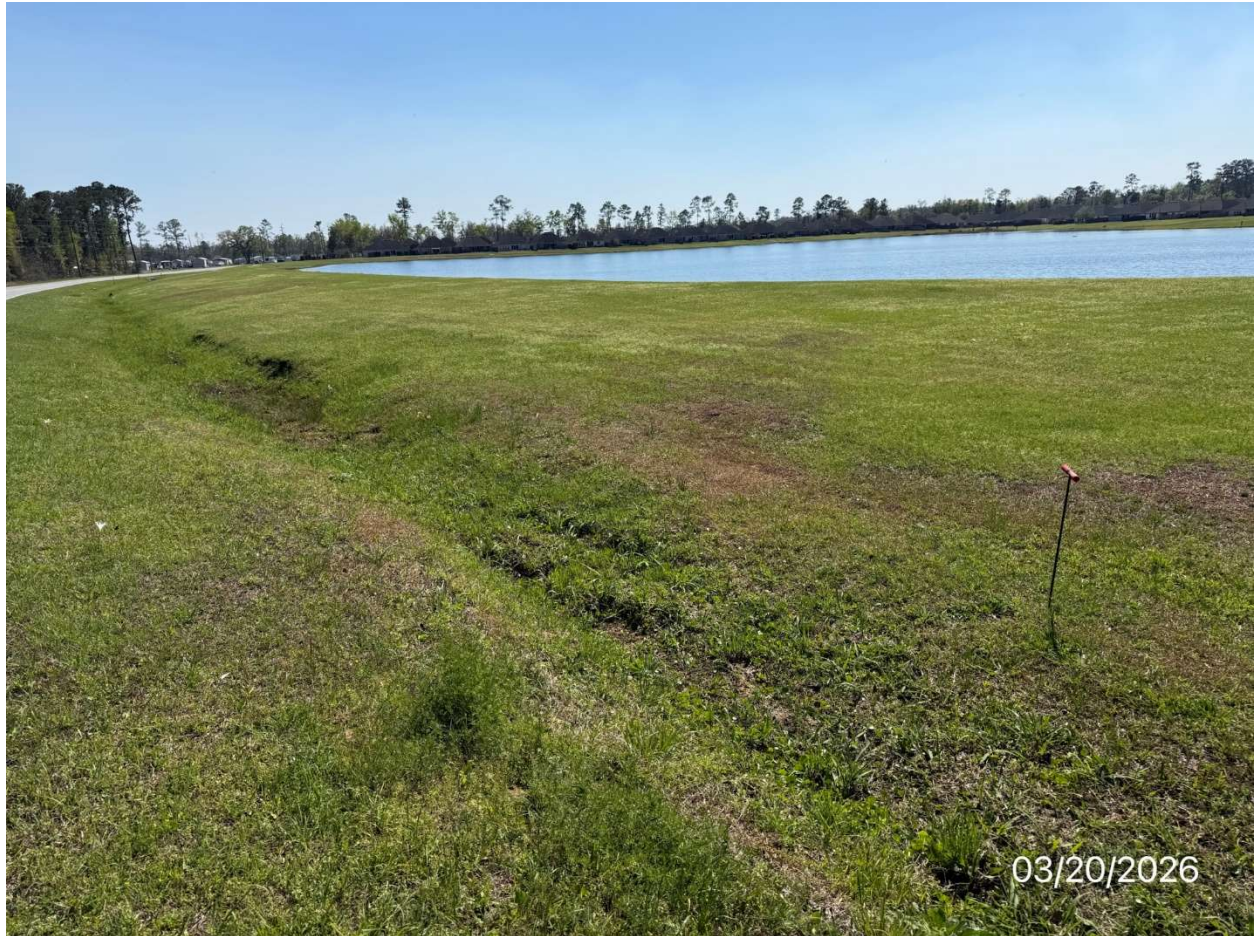
Picture #8 - Typical downstream slope.

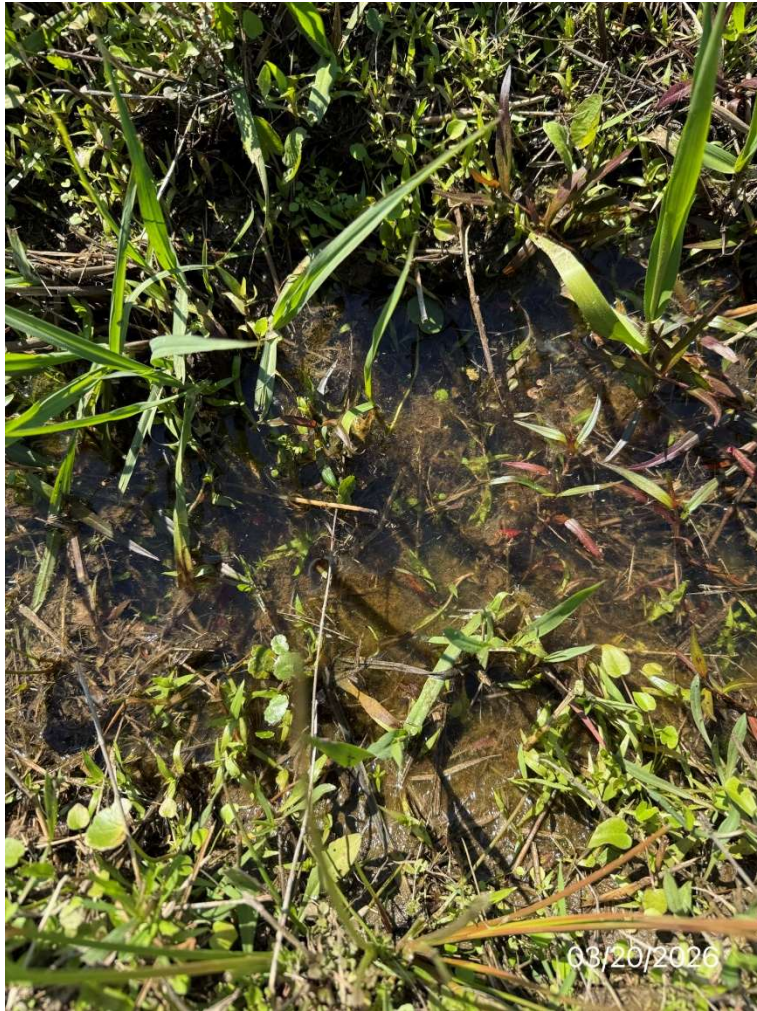
Picture #9 - Typical standing water in the ditch on the downstream slope at toe of the dam. Mostly hydrophilic vegetation on the ditch and the ditch does not drain well. Water is clear and is not flowing. See the attached location map.

6. Are there any wet areas or areas of hydrophilic (lush, water-loving) vegetation? Yes X No _____
If yes, describe (size of area, location, etc.)/Corrective Action: Hydrophilic weeds and grasses cover the bottom of the toe of slope/road ditch most of the length of dam. The ditch is flat and does not flow well.

9. Other observations on the downstream slope/Corrective Action: In general, soft to very soft soils exist at the toe of the of the dam. However, little erosion or evidence of movement exists. The ditch (i.e. toe) stays very wet presumably due to a flat slope in the ditch. Monitor.

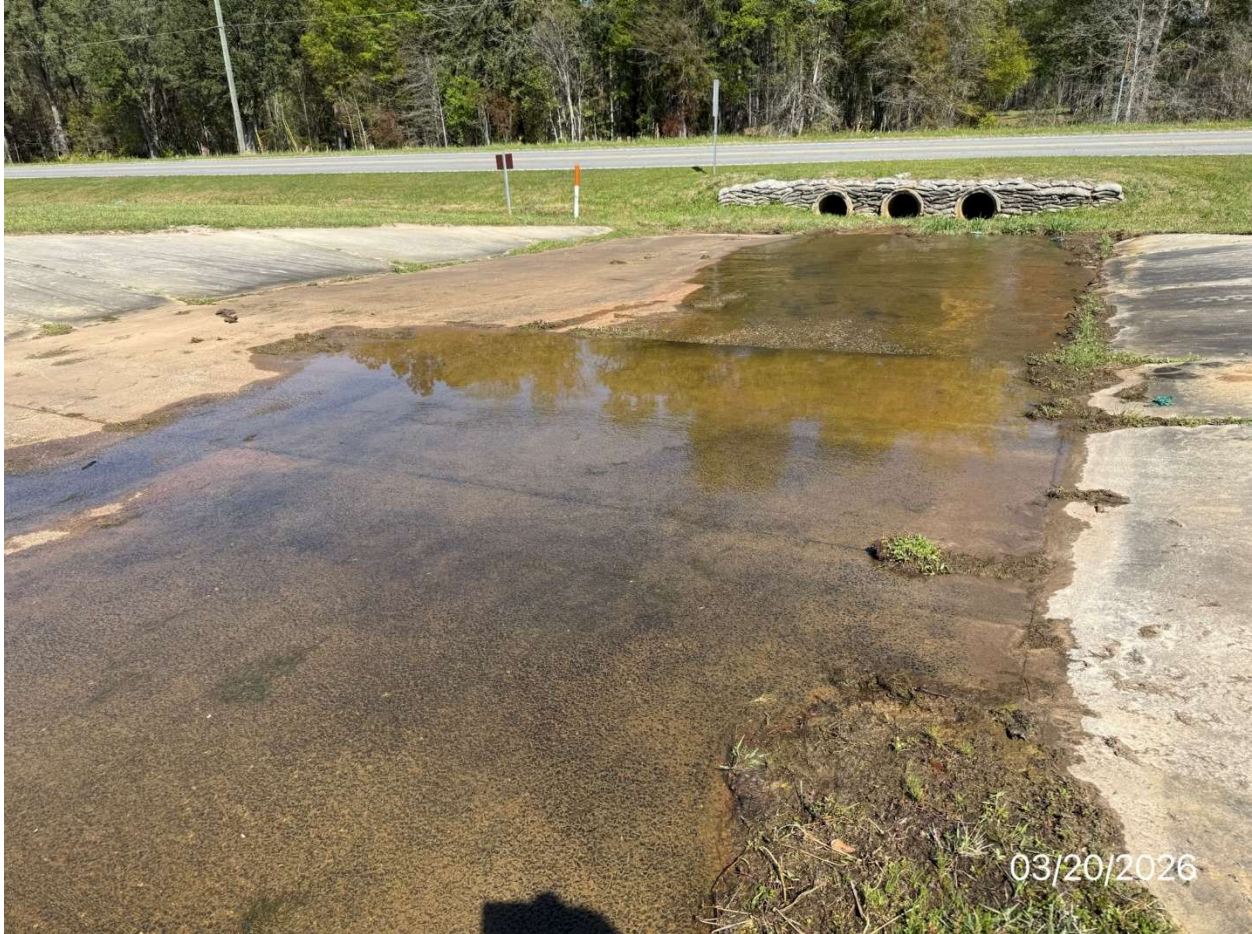
The principal spillway (a concrete overflow spillway) appeared to be functioning as intended with no visible obstructions or signs of leakage. The discharge immediately entered triple 30" RCP under Val Der Road. Some settlement has occurred at the southwest corner slab on the upstream slope and at the southeast corner slab on the downstream slope.

Picture #10 - Principal Concrete Spillway Channel.
(Triple 30" RCP culverts under Val Der Road are shown in the background. These culverts are not a part of the dam or outlet system)

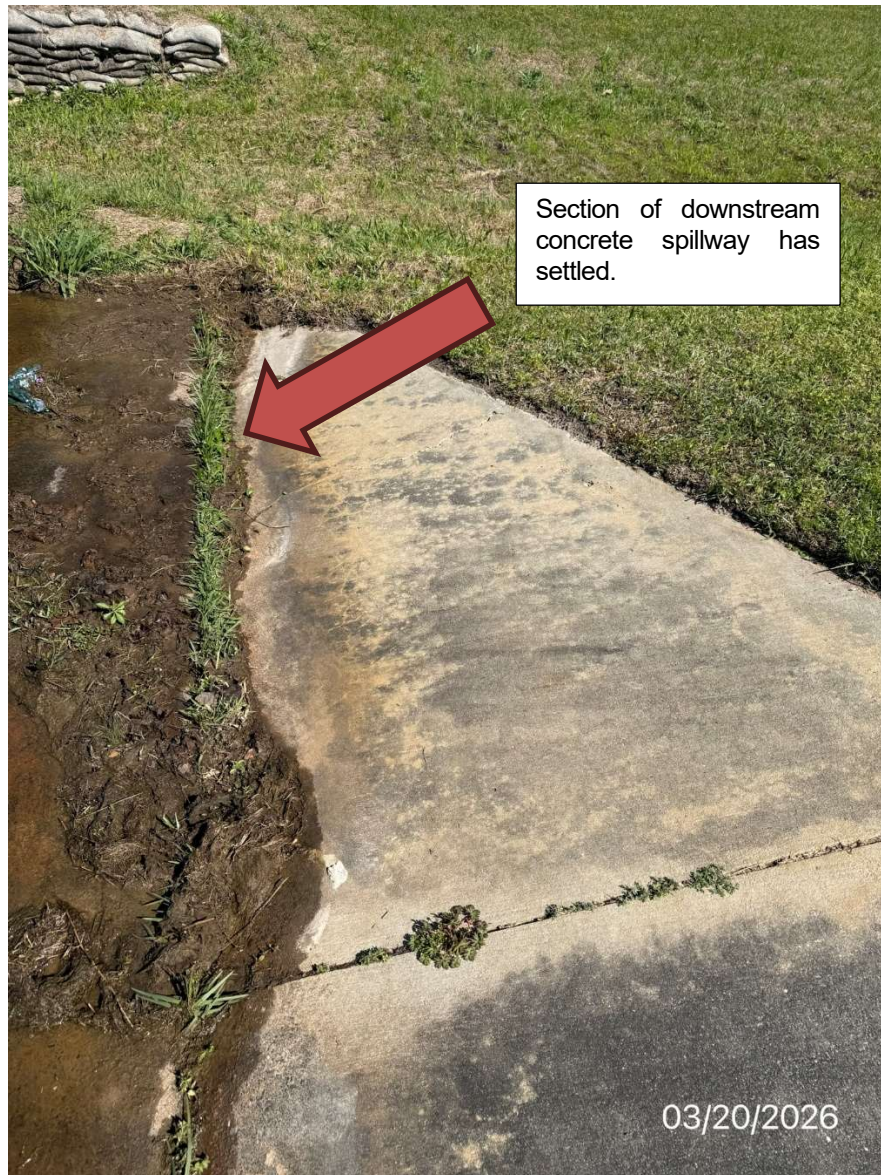
Picture #11 - Concrete slab at the southeastern corner of the concrete spillway. Downstream slope, slight settlement.

- 12. For concrete channel spillways, are there any cracks or holes in the spillway? Yes X No _____
If yes, describe (width of crack or hole, location, etc.)/Corrective Action: The main section of the concrete spillway is in good condition. There is only slight erosion at the downstream outlet edge. Two side pieces have cracked and settled. See pictures # 11 & 12. Monitor for additional settlement.

- 1 Monitor local settlement on the sides of the concrete spillway near the southeastern (downstream side) and southwestern (upstream side) ends on a quarterly basis. If flow develops under the spillway or if the concrete shifts or continues to settle, notify the Engineer of Record or Safe Dams Unit at EPD.
- 2 Monitor downstream slope of dam quarterly to observe any cracks, sloughing or sliding. One minor location was identified on the backside of the dam north of the concrete spillway.
- 3 Place additional soil on the dam crest at multiple bare locations, bring soils to surrounding existing elevations, and revegetate.
- 4 Eradicate ant hills located across the length of the dam with appropriate chemical measures.

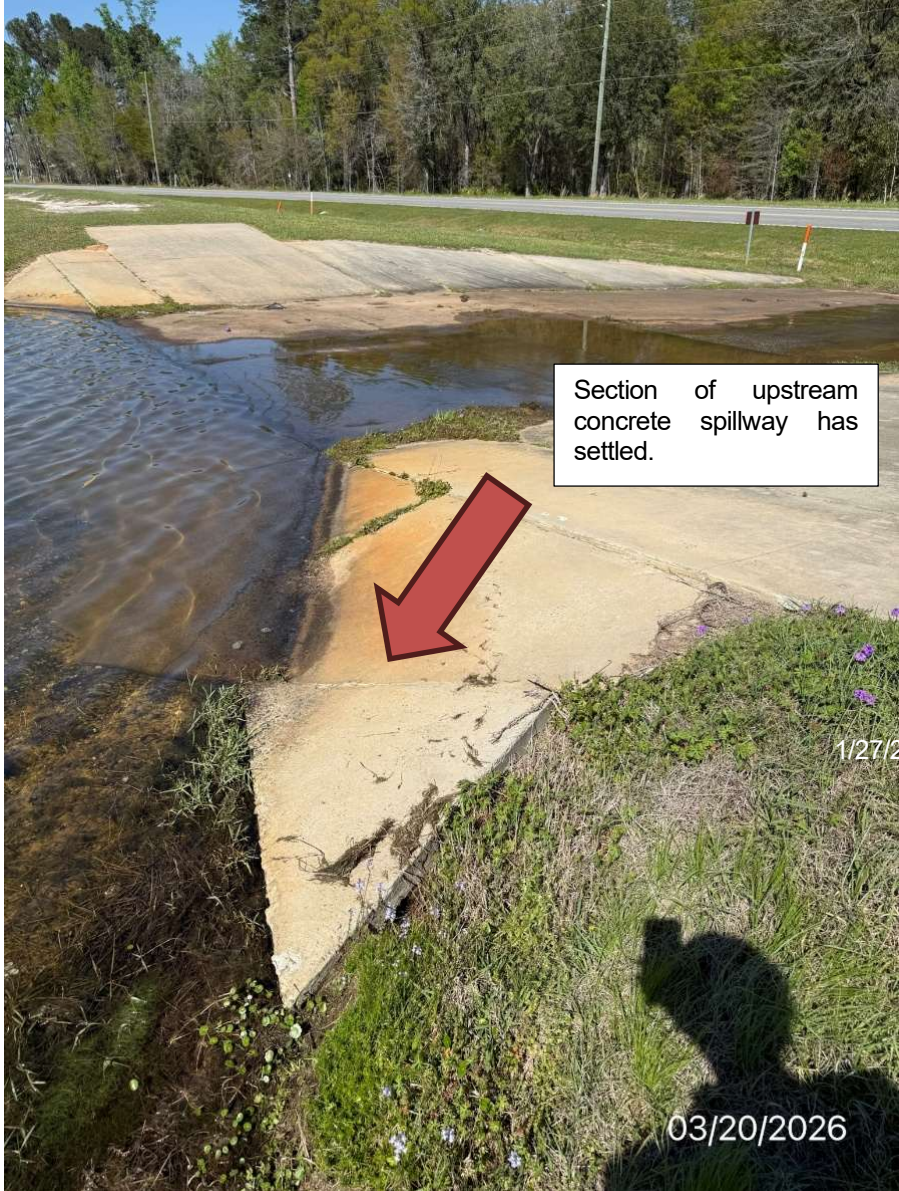
Picture #12 - Concrete slab at the southwestern corner of the concrete spillway. Upstream slope, slight settlement.
